**EVALUATION OF HIGH-PERFORMANCE CONCRETE (HPC) BRIDGE DECK  
CONSTRUCTION REPORT**

**Project Name:** South Helena Interchange

**Project Number:** NH-STPU-CM-MT-STPE 15-4(108)191

**Type of Project:** Experimental trial of high-performance concrete (HPC) for placement in interstate bridge deck

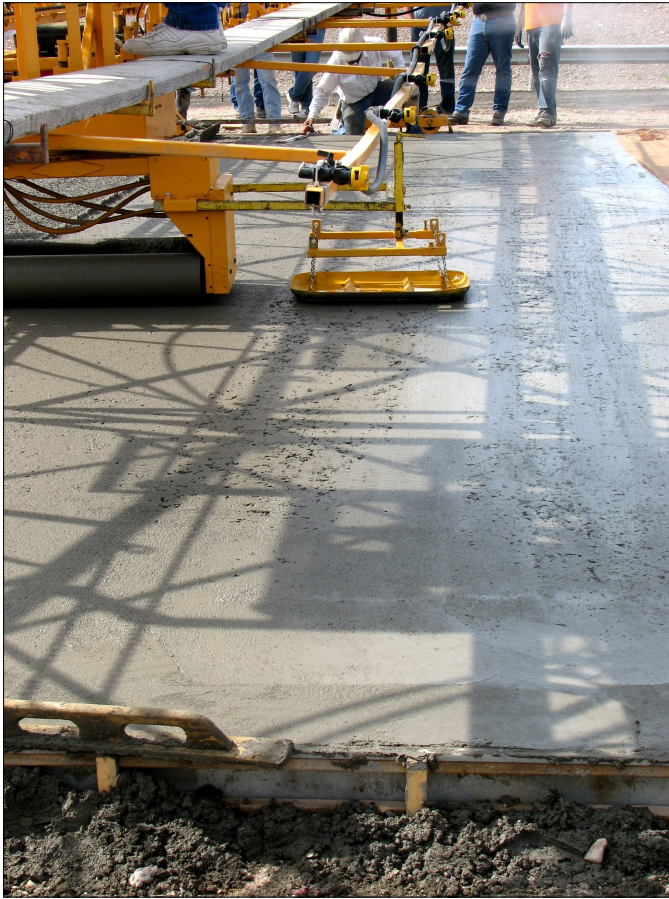
Towards the end of placement of the HPC, the concrete production plant had a mechanical problem which delayed the delivery of the last few loads. Although the contractor did a good job in keeping the PCCP moist during the delay, there was ripping and tearing of the mud once the Bidwel deck paver was back in operation. The contractor was able to eventually get the surface to a normal appearance.

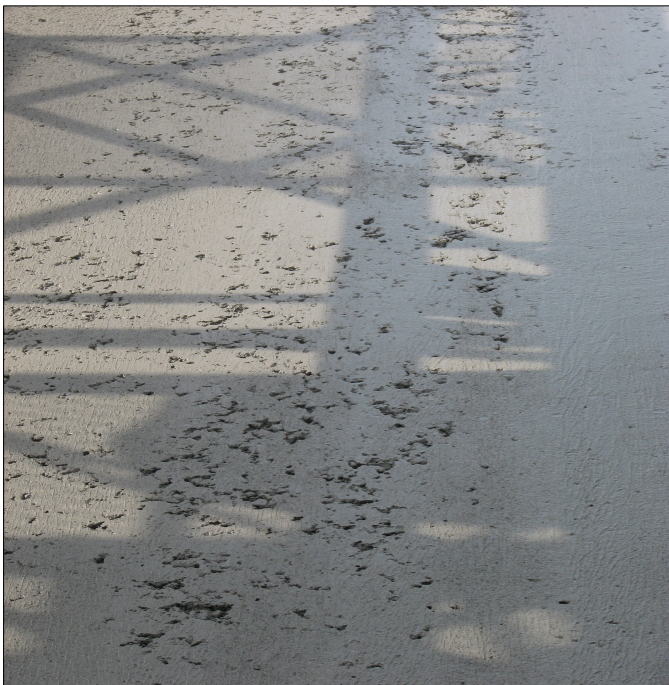
Close-up of tearing of PCCP during placement.

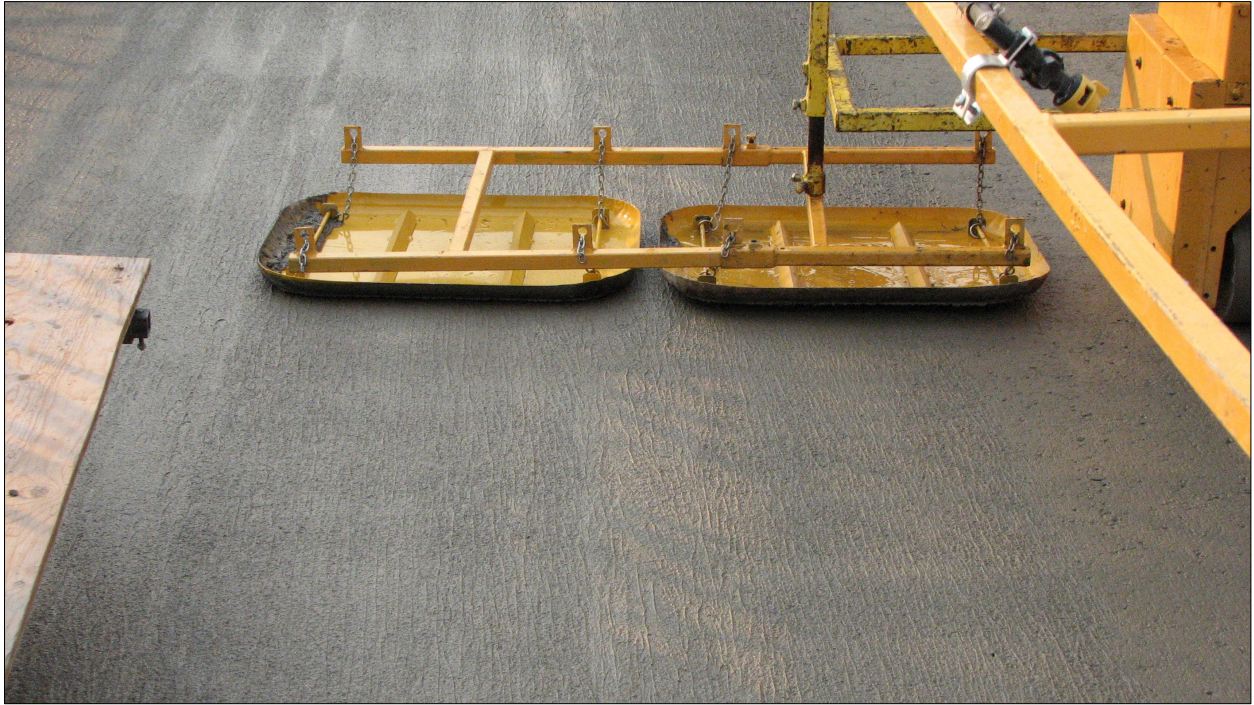
↑ The contractor switched from a finishing single pan operation to a double pan configuration with better results for surface texture.

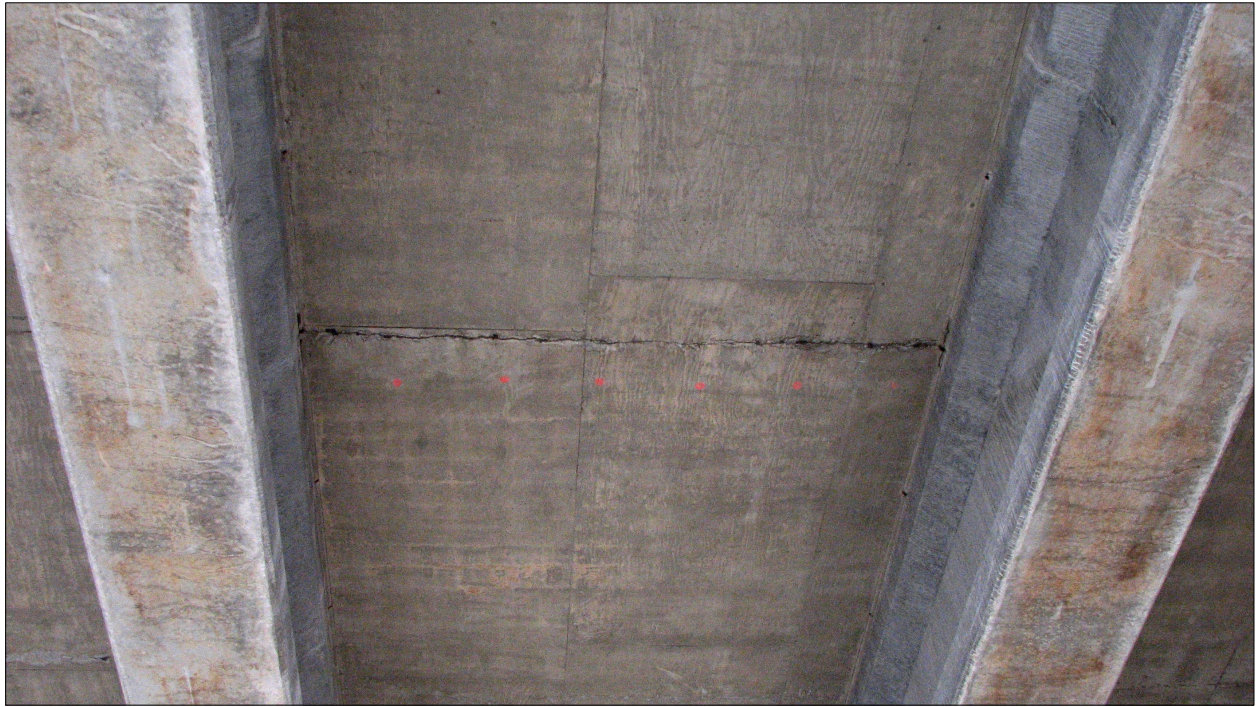
↑ Example of hairline crack in southwest quadrant pours.

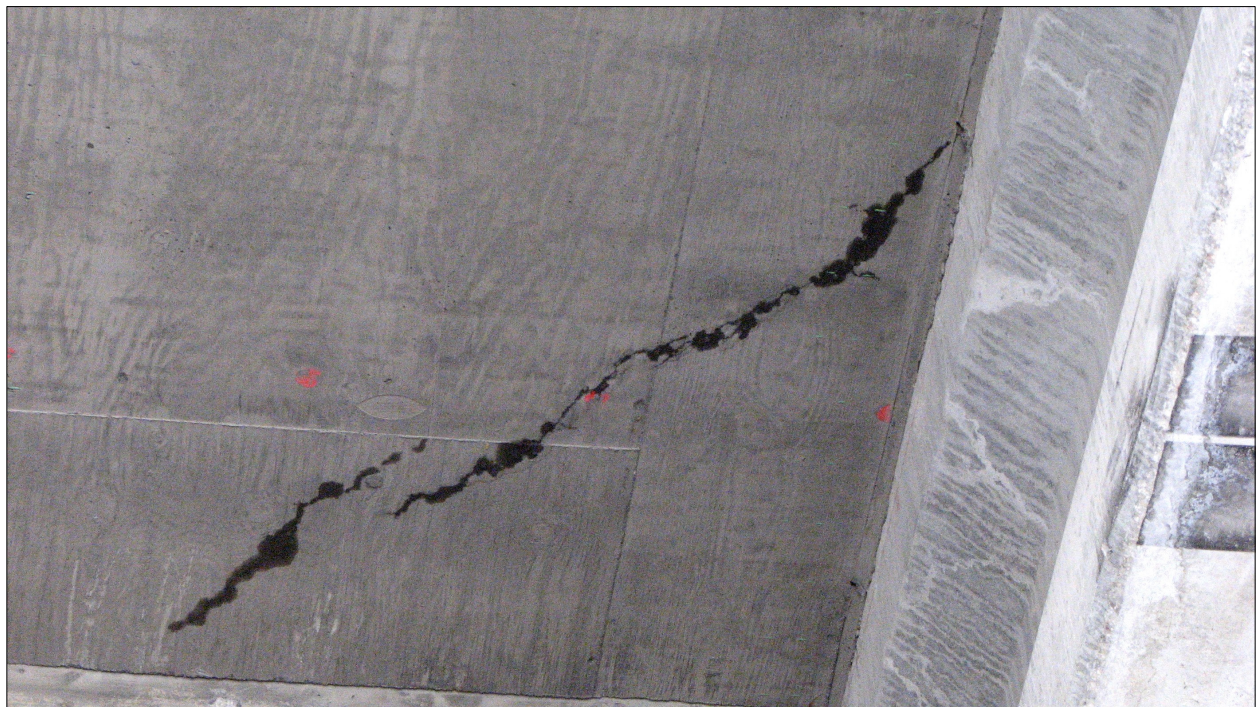
↑ Example of weeping corner crack at southwest area of deck.

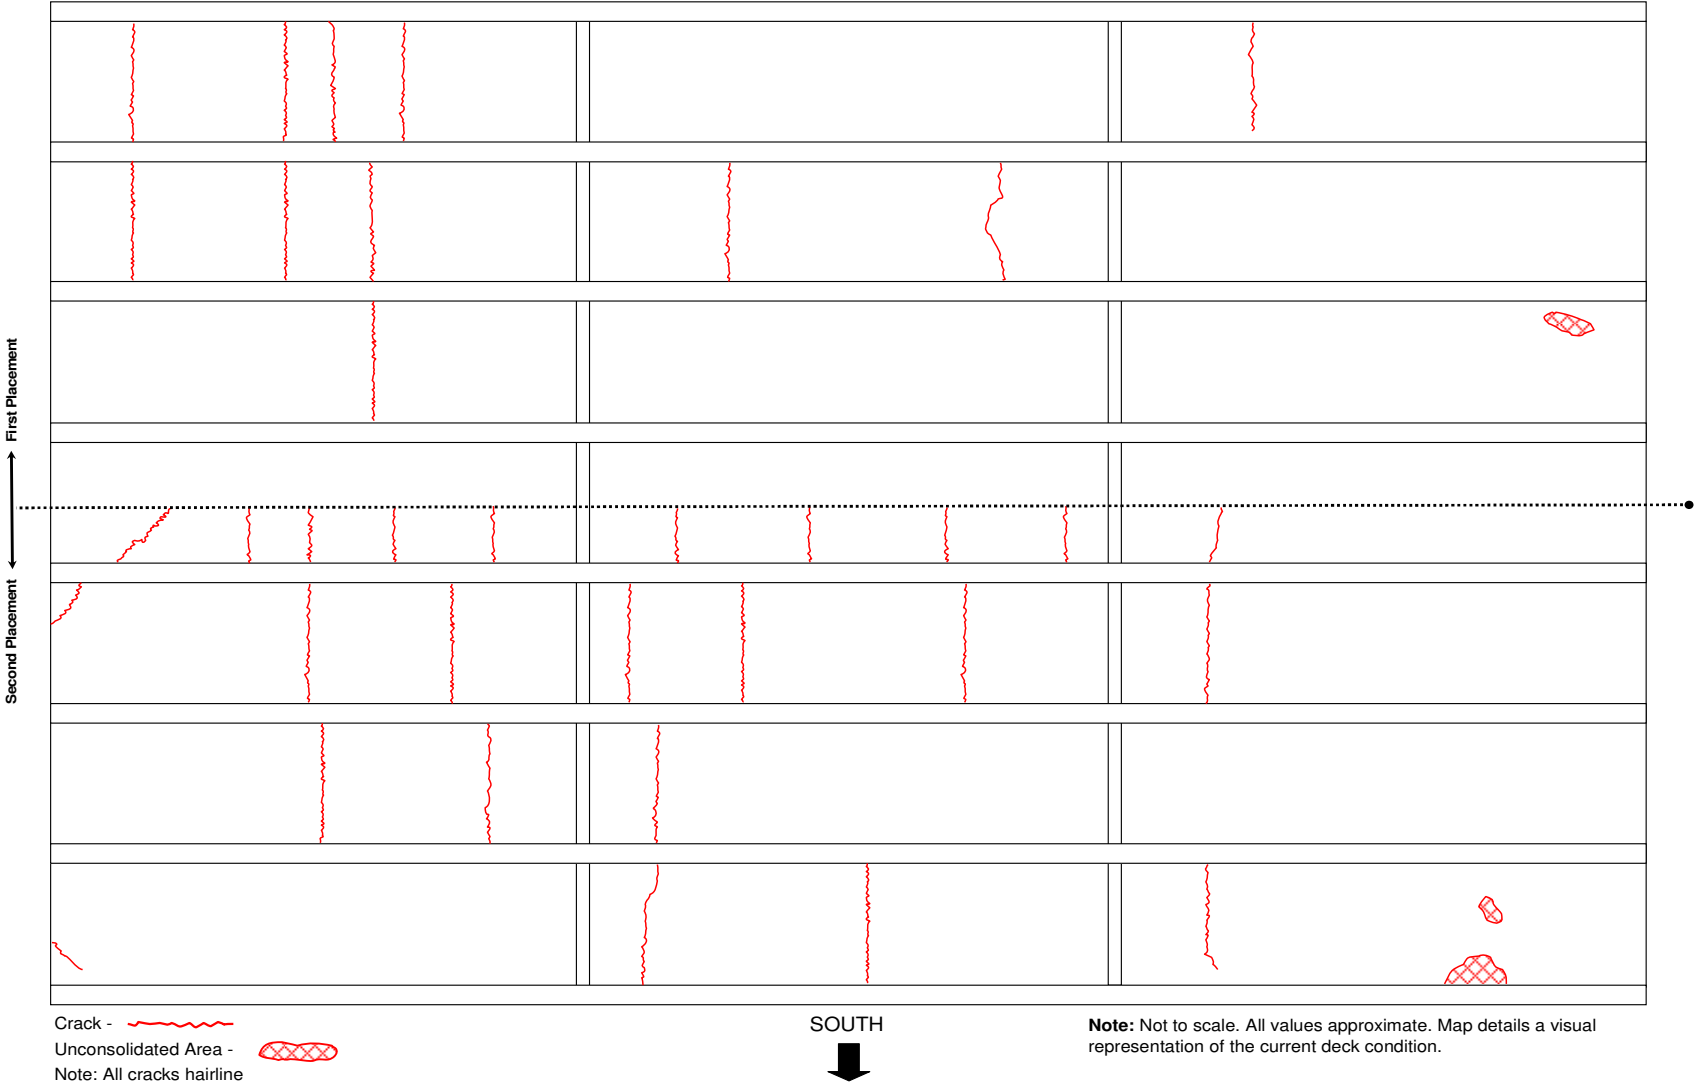
UNDERSIDE- WEST HALF: Deck condition as of August 2007

Note: All cracks hairline
